MULTIPLE FUNCTION SWITCH UPDATE ROTAX 125 MAX evo engine series

Multiple Function Switch

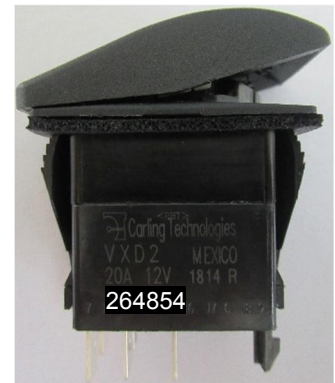
The removal of grease is only valid for the connector of the switch, not for any other connector of the wiring harness!

2) Removal of grease from the connector

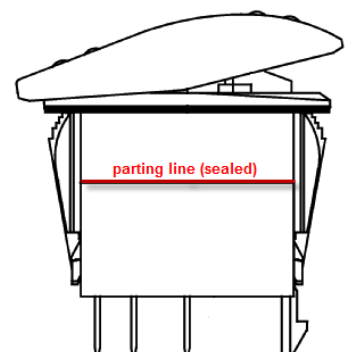
NOTE: The switch is sealed on the parting line to prevent water intrusion.

For this reason, the switch must not be opened!

By opening the switch this will break the sealing which can cause failure and warranty becomes void.
