MULTIPLE FUNCTION SWITCH UPDATE ROTAX 125 MAX evo engine series

Multiple Function Switch

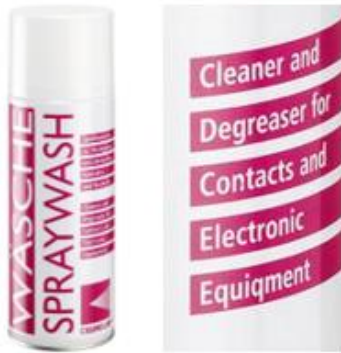
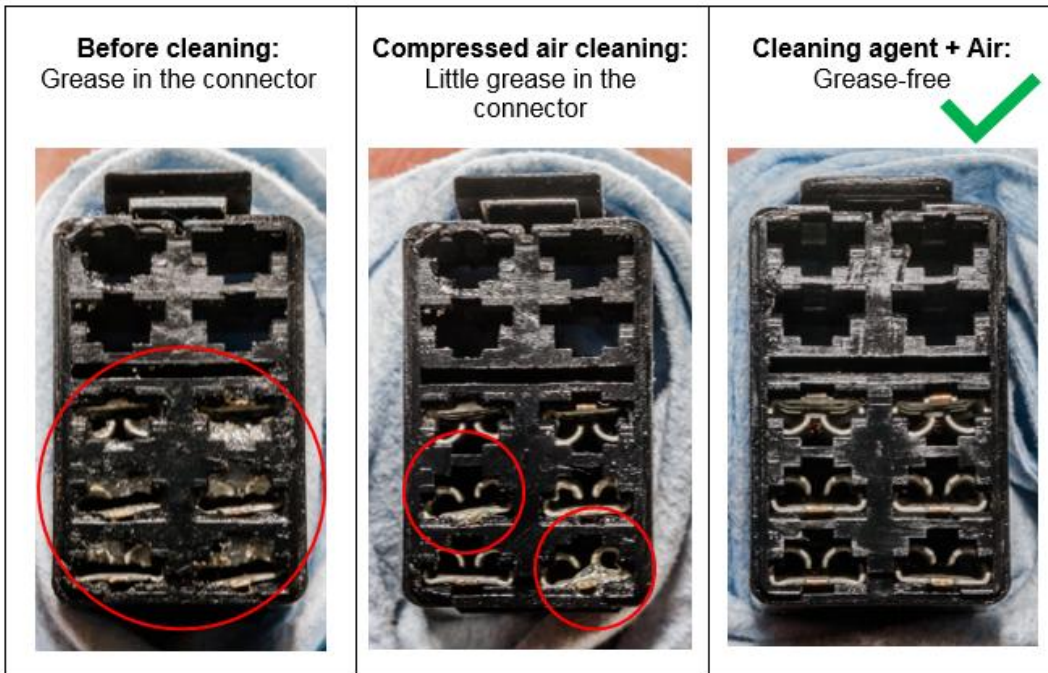
NOTE: Replacing the switch only, without removing the grease will lead to a failure again!

Recommended cleaning products:

Contact Cleaner (e.g. Spraywash) or Brake Cleaner (e.g. XPS)
